Comanche Landing Gear Maintenance session at Ellenville NY

Dwight Coombe, host for the May 16, 2015 NE fly-in at Resnick Airport, lead an in-depth discussion on issues related to the Comanche landing gear system. The topics covered possible causes for circuit breaker overloading, improper installation of bolts resulting in gear movement interference, improper installation of wishbone linkages, and the emergency gear release spring missing or disconnected. Those in attendance provided accounts of problems with these items and the resulting actions taken.

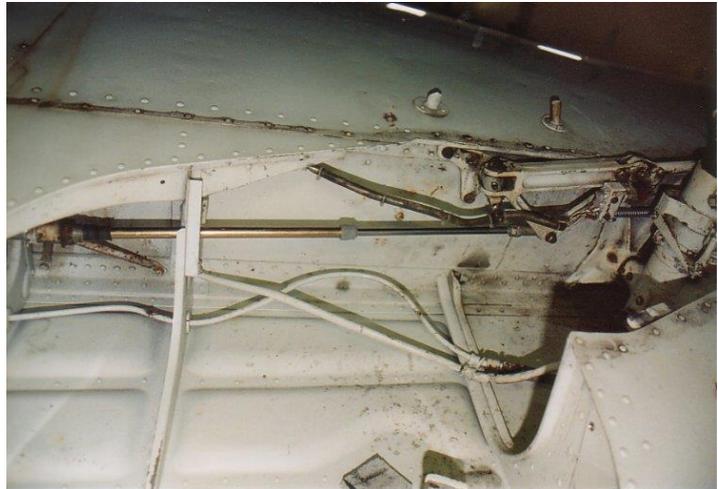
gear conduit in wheel well

Most overloads occur when raising the gear, particularly in the last few inches of travel when the loads are higher. One cause could be excessive crud accumulated on the gear conduit telescoping tubes. Peter Morse had a gear collapse on landing due to this problem. Another could be failure of the up-limit switch, located in the rear of the nose wheel well, to close. This failure can be caused by improper adjustment or as a result of extremely cold temperatures. A third cause could be interference with the gear movement due to improperly installed hardware, failure of the oleo legs to fully extend, or crud (mud or ice) on the wheel or in the wells. Many of these problems can be detected by following the gear level through its travel with your hand. If the motion slows down that indicates an increased load. If there is a shuddering felt in the lever this could indicate a worn worm gear. Unfortunately trouble free gear actuation while on jacks does not preclude problems in the air.

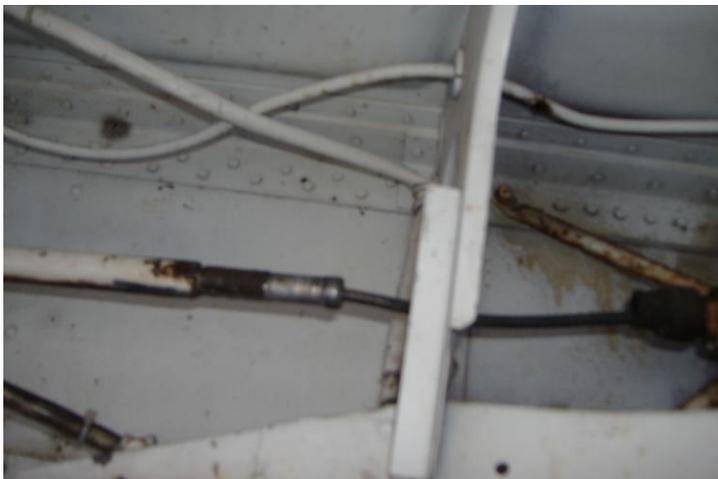
conduit jammed by crud

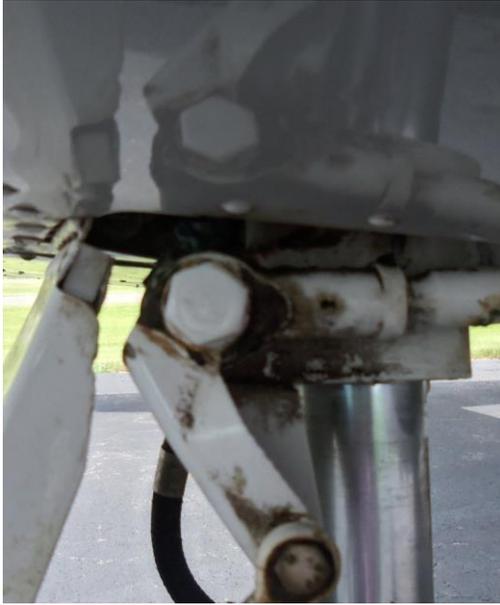
flat head bolt

There are a couple of bolt fasteners that, if installed improperly, can result in contact with the wing underside and/or wheel well. This can result in damage to the sheet metal structure and prevent further movement of the gear. Refer to the Piper Service Manual for proper assembly or take a photo before disassembly. Gear actuation while on jacks should reveal any problems.

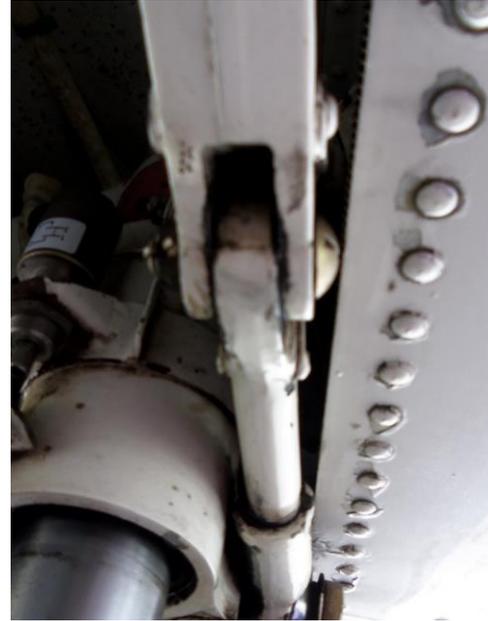
round head bolt clearance

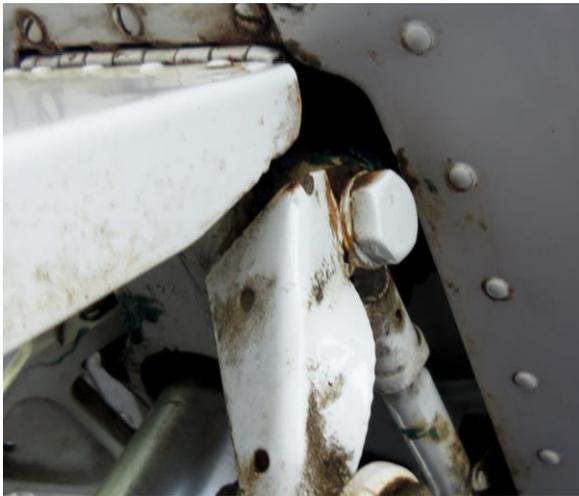
flat head bolt clearance

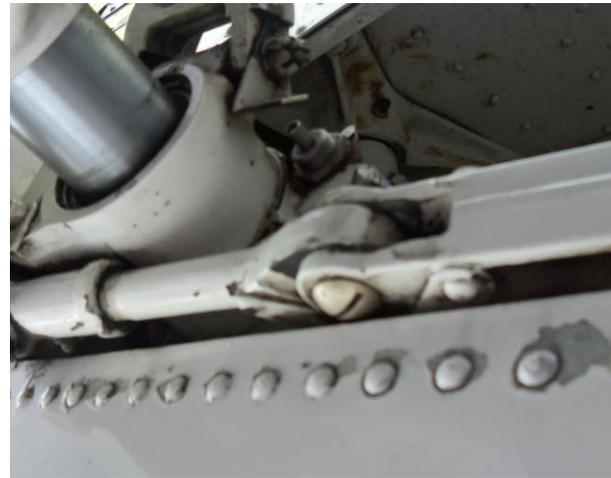
round head bolt

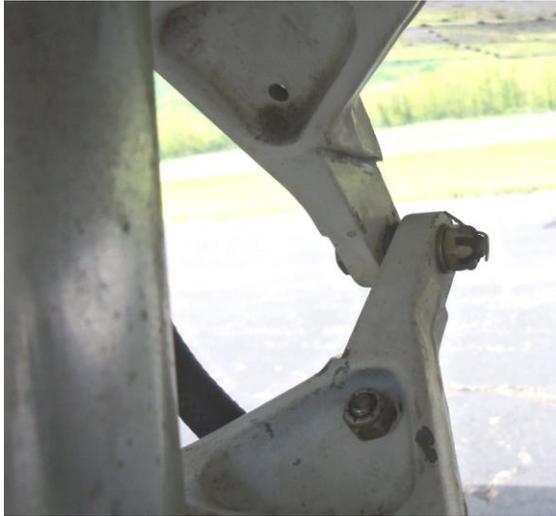
good main link

The wishbone linkages on each gear leg provide directional control while allowing the gear to flex up or down. Each wishbone arm has an area milled in the side which, when properly lined up, allow the assembly to compress further without binding. This allows full deflection to the gear oleo struts. Should the assembly bind up the resulting stress can shear the bolt positioned at the knee joint. Without this linkage the oleo strut is free to rotate. The nose gear will produce a definite vibration, but tend to track in the direction of motion. The main gear will likely rotate 90 deg to the direction of travel with the tire dragging sideways on the surface. Bernie Stumpf had this occur when landing at Westerly RI, closing down the runway for nearly an hour. Without care, each wishbone arm, as well as the entire assembly, can be installed backwards. When properly installed the milled areas should face each other and the flat notch surface should be relatively horizontal to the ground. Zach Grant

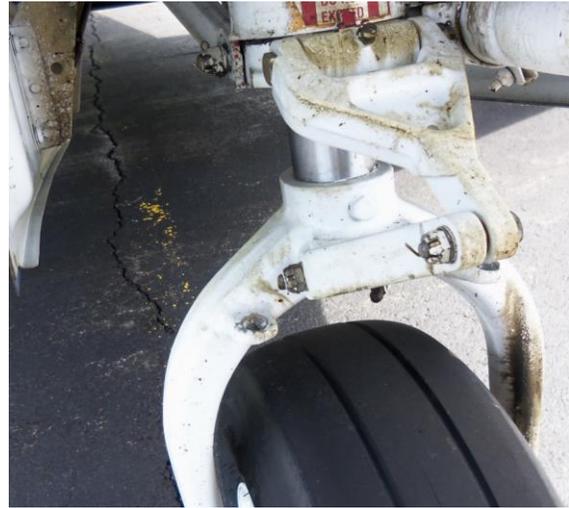
good nose link

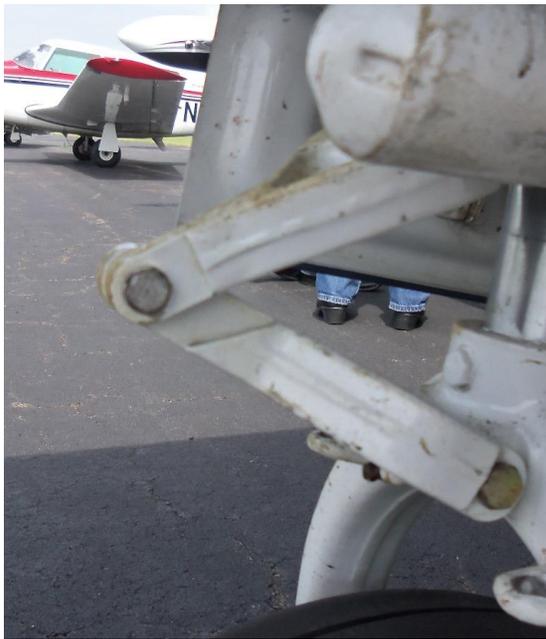
good nose assembly

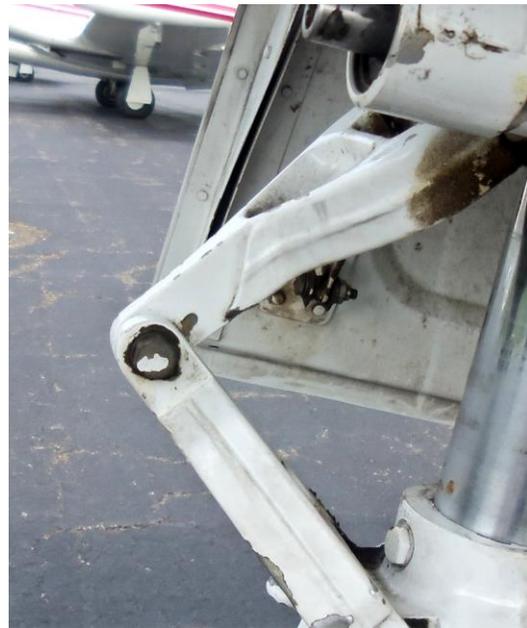
reversed nose assembly

commented that, at one time nearly 18% of the Comanche fleet had improperly installed wishbones, many as factory original.
