Instructions for Removal, Inspection and Replacement of the Torque Tube Assembly, and Pitch Control Horn, PA-24/30/39

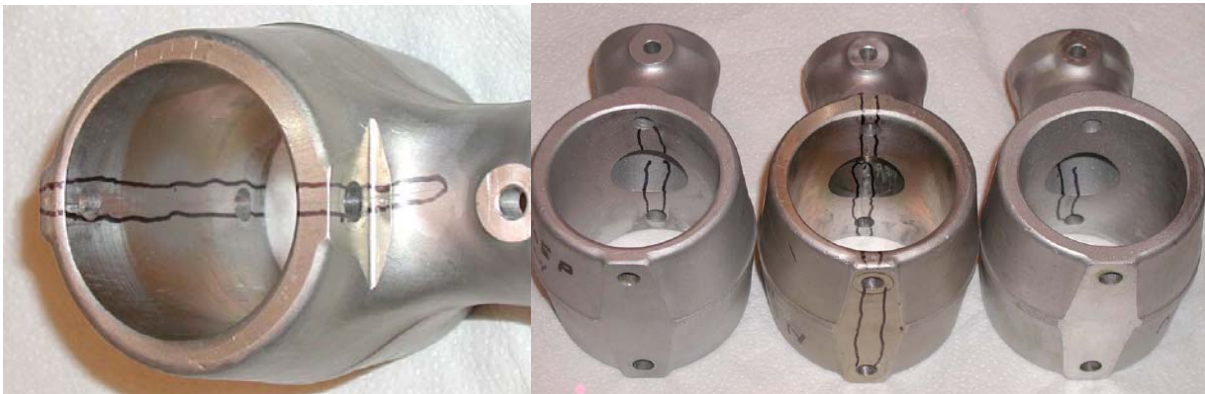
16. Inspect the inner boar of the horn by an appropriate means, for cracking, radiating horizontally from any bolt hole, or in the shoulder of the center boar for the balance arm. If no cracking is found, chamfer the sharp shoulder of the balance arm boar to relieve future stress. If cracking is found, replace with serviceable horn assembly. If excessive corrosion is found on torque tube, replace with serviceable torque tube.

15. Same note as #12
16. Some examples of cracking:
